## Beaufort Castle, Lebanon; conservation versus restoration project

**ABSTRACT:** Beaufort is a medieval castle that witnessed a succession of construction and destruction till today. After the year 2000, local authorities commissioned a team of experts to make an assessment of the current status of the Castle. At the end of this assessment, an exhaustive tender document package became available and ready to be executed by contractors. Local inhabitants expressed the request to “rebuild” the castle the way it was before the recent wars in Lebanon (1975–2000). This approach would jeopardize the authenticity of the monument. The team of experts had therefore to analyze the different structures of the castle in order to define different approaches one should have regarding this matter. This paper presents the methodology adopted in choosing the different approaches needed to establish the tender document for the conservation and restoration of the Beaufort Castle.

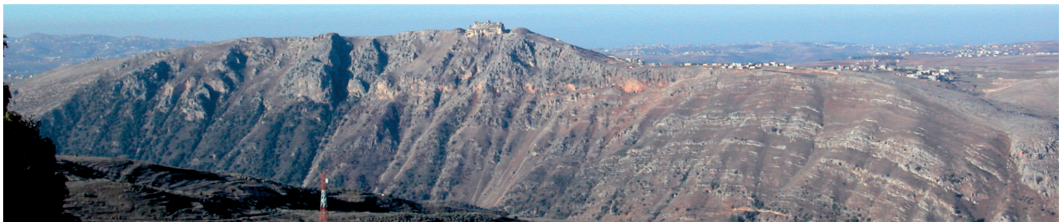
Figure 2. Cliff on which Beaufort is located. 2002 © J. Yasmine.

The castle is located directly over two parallel faults. One of the major earthquakes that affected the castle in the year 1837 is probably caused by the proximity of these faults. Note that the 1837 earthquake epicenter was located on the *Roum* fault from *Saida* towards *Marjeyoun*. Elnashai & El Khoury, (2004) 35–37. This fault is therefore very close to Beaufort.

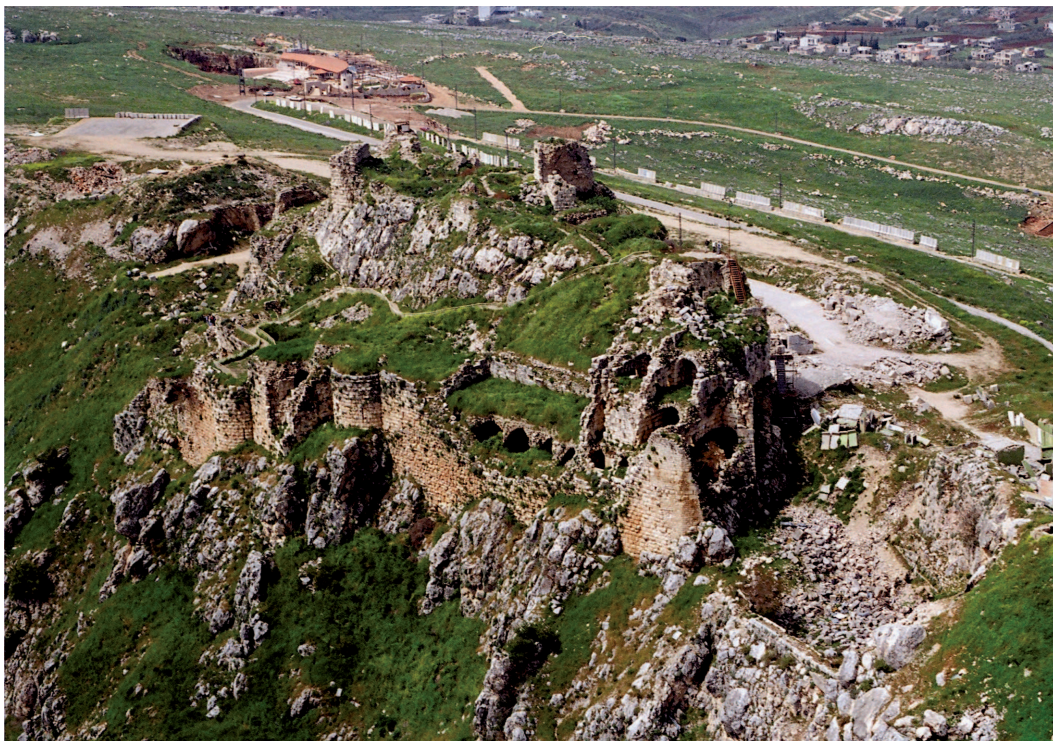
Figure 4. Airplane view of the lower castle. 2003 © J. Yasmine.

It has four levels and includes many defensive constructions (circular and rectangular towers) located on the southern and eastern fronts. Close to the gate -A-, a great vaulted hall and many rooms are developed

on two levels and lead further to the eastern fortifications. These last constructions comprise two circular towers and a rectangular one, all built up in the Ayyubid era. The rectangular tower is composed of three rooms covered with crossing vaults on two levels; this construction suffered of direct bombing and is subject to a detailed structural study. Further to the north, a gallery leads to a succession of rooms and then to a four storey building (building -H-) that suffers also of big structural problems. In the southern part of the lower castle, an open air path controlled by the upper castle leads to its entrance.

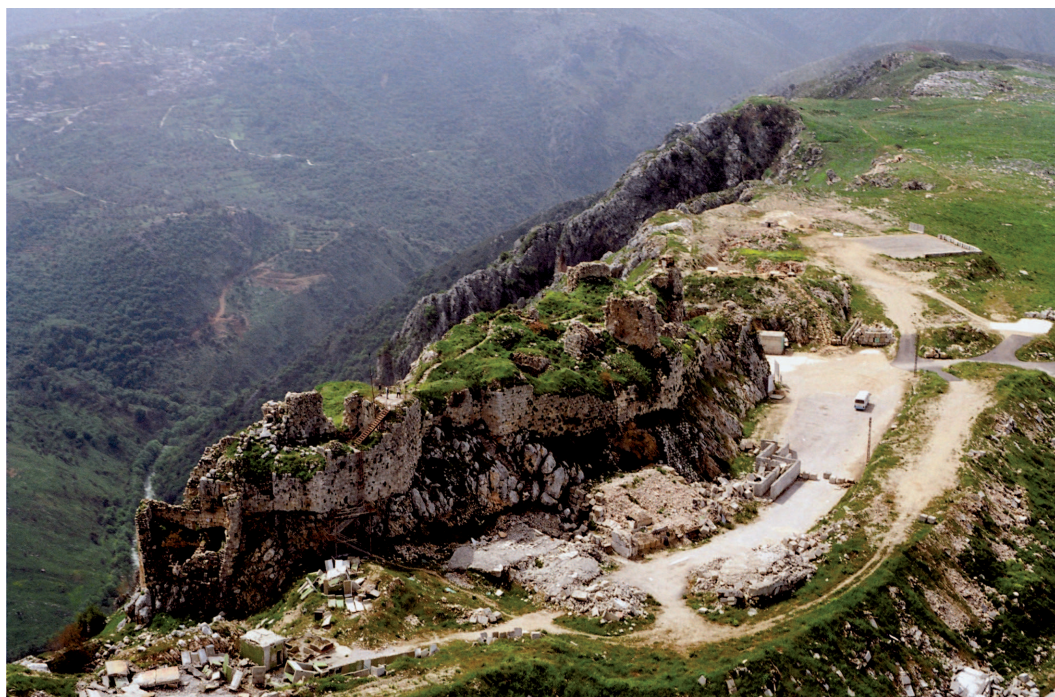
Figure 5. Airplane view of the upper castle. 2003 © J. Yasmine.

Its entrance is from the southern side. An uncovered path follows the gate -B- and leads to the main gate -C-. This path is controlled by a shield wall that constitutes the southern edge of the upper castle. The gate -C- is constructed within this shield wall. It is today partially destroyed. After this last gate, the ruin of the castle covers the ramp that reaches the top of upper castle. In this last part, we can find the main constructions of the castle, its dungeon, its “grand-salle” and its residential tower (the tower -E). The defenses of the castle at the South and West side are constituted mainly by towers, walls and glacis; to the east, remains of the base layers

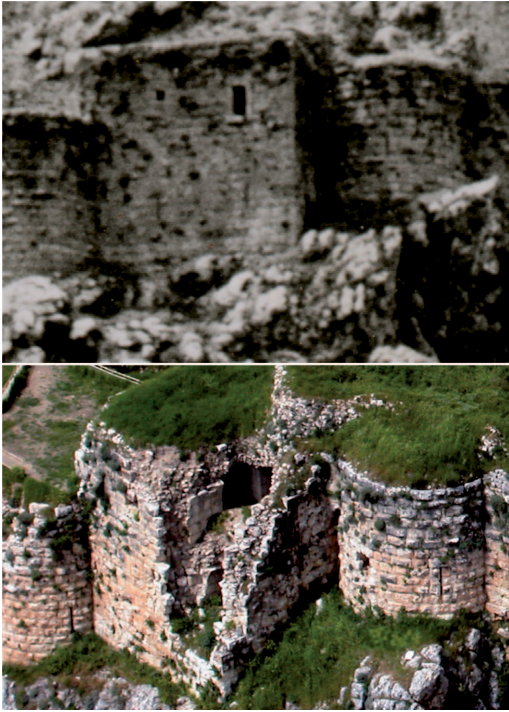
Figure 6. The ayyubid rectangular tower in 1947 after DGA documentation fig. 121a; and in 2003 © J. Yasmine.

This ayyubid rectangular tower was partially destroyed in the year 1982 after an airplane bombardment. The result of the shelling was the complete destruction of one vault of the upper and the lower floor, and

partial destruction of other surroundings walls and vaults.

It was obvious that this destruction allowed the clear understanding of the construction technique, the integration of the tower in the natural slope of the cliff and the strategic importance of the castle set up in its environment. From many points of view, the conservation of the current destruction was appropriate in opposition to the restoration of the previous original status. Our major concern was the current structural behaviour of the tower. A structural assessment was therefore undertaken.

- *Preliminary structural assessment*; it shows that some voids resulting of the shelling should be filled with masonry coherent with the historical construction techniques. The eastern elevation has unstable parts of walls resulting of the shelling. The foreseen actions consist of stabilizing the walls and other structures of this tower.
- *Detailed structural assessment*; a conservation of the current status of this tower is not possible if the analysis of its structure, as it is today, does not show that it is 100% stable.

The graphical analysis of forces in the building shows that the tower is stable if the partially destroyed

vaults are consolidated in their current status. The foreseen intervention is therefore finalized as follow: consolidation of the dismantled and the weak parts of the walls and vaults; restoration of the small gaps and voids in walls and vaults; implementation of discreet handrails to secure tourists visits.

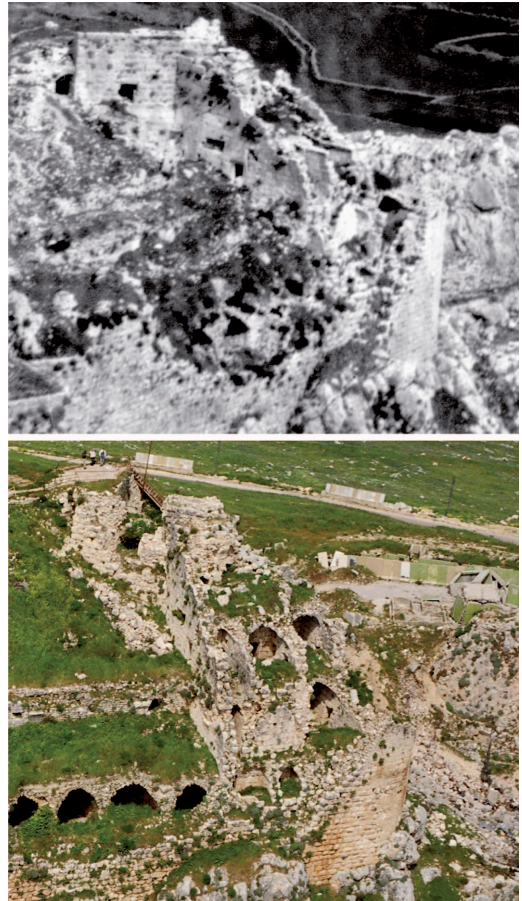
Figure 7. Building H in 1935 © IFPO doc. no. 20384; and in 2003 © J. Yasmine.

The building -H- is a complicated building with many historical strata overlapping. It seems that some layers are of the Ayyubid / Crusaders period while the main building is Mamluk.

This building was not hit by direct shelling during the last war. Nevertheless, it suffers of major structural problems. The preliminary structural observation shows out of plumb on the two elevations facing the valley (the North and the East elevations). It is therefore essential to undertake an accurate assessment of the cracks and other structural problems one can

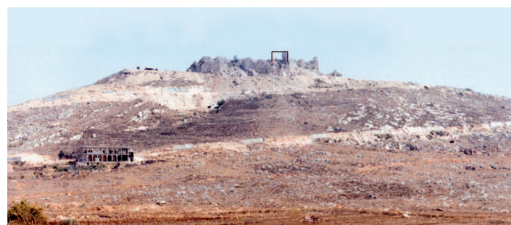
Figure 9. The skyline of the castle from West and the foreseen restitution of the dungeon. 2000 © J. Yasmine.

from many points of view. In the visual memory of the place, the dungeon was the main tower of the castle. People coming from *Arnun* towards Beaufort identify the castle according to the skyline of its upper part (and mainly thanks to the presence of the dungeon) (Fig. 9). This is the main reason for which the restoration of the dungeon is considered. On the other hand, the available historic documentation, and the presence on site of many dismantled blocks that are still in good condition make this restoration possible. The aim is not to reconstruct the whole dungeon; what is foreseen is just the restoration of the status of the year 1975 before the bombardment. The old photos showing the elevations of the dungeon before its destruction are ortho-rectified. The restoration project is designed in accordance with this documentation. Some very limited additions on this status, for consolidation purposes, are tolerated.
